Tennessee ForestWatch Water Quality and Best Management Practices Report

Date: Dec. 7, 1999

Location: NW of Graysville on N side of Brayton Mtn. Rd. near border of Rhea and Bledsoe Counties.

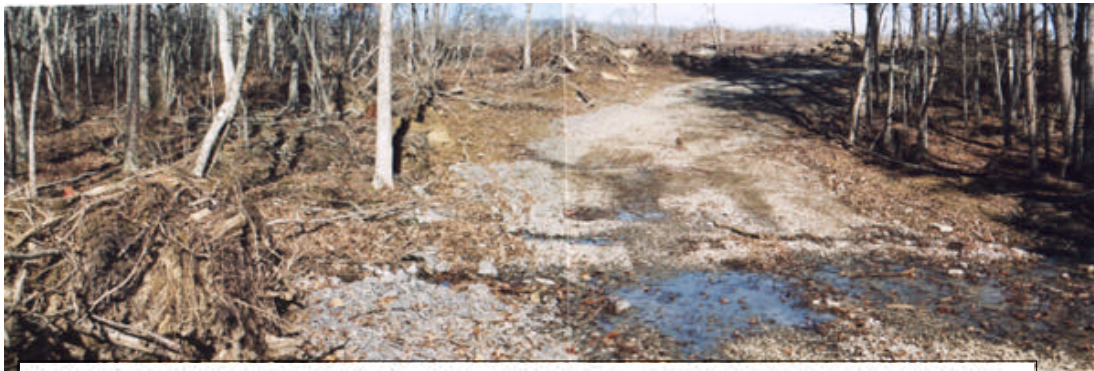
Eastern Stream Crossing (see Fig. 1)--except where disturbed, the stream bed is composed of medium to large sized stones and leaf litter. The water above the crossing was very clear and the water below the crossing was cloudy with foam on the surface.

- Haul road failed to comply with BMPs (no water bars or broad based dips)
- Roads had not been stabilized by seeding vegetation
- A discrete, discernible channel cut through the dirt on the eastern edge of the haul road; via this channel or ditch, soil, dirt, and sediment from the logged area above the stream was entering the water body. No attempt had been made to turn this water out before it reached the water body.

- Soil, logging debris, and root clumps had been left in the stream causing a dam that prevented the stream from flowing freely and diverted the stream from its normal course. This caused an impediment to the movement of aquatic species.

- Gravel had been placed in the stream bed preventing the free flow of water, raising the level of the stream bed, and causing the water to disperse over a 5-6 ft. wide area where there was no longer a discernible stream bed. This caused an impediment to the movement of aquatic species

- Loose and unstabilized dirt and soil had been placed, piled, and exposed on the stream banks. This resulted in continuous siltation and erosion.
- Heavy deposits of sediment were observed downstream of these disturbances.

- Foam was observed downstream of these disturbances.

Figure 1. Eastern Stream Crossing. Root ball and debris at left is damming the stream which is forced to seep through gravel placed in the stream bed. The gravel has raised the level of the stream bed and causes the water to disperse

(4) Complaint: Logging debris and root clumps left in the stream impeding aquatic movement

This had been removed prior to our inspection.

(5) Compliant: Gravel placed in the stream bed impeding water flow

This condition no longer exists. Gravel still covers the streambed, but it does not restrict water flow or movement of aquatic life. This may have been corrected when the debris was removed.

(6) Complaint: Loose and unstable dirt exposed on the stream bank

There is one pile of exposed soil on the edge of the stream. This is approximately the size of an office desk. We recommended seeding this area as soon as the weather permits. Also, a silt fence should be placed

(7) Complaint: Heavy deposits of sediment downstream of the disturbances
Sediment deposits below the crossing were observed. The best course of action is to eliminate any further erosion from entering the stream and not disturb the soil that was observed. I do not consider the soil deposits to be heavy.

- Construct broad based dips or water bars on all roads to turn out storm water before runoff reaches streams.
- Plant vegetation on all roads to stabilize soil.
- Plant vegetation or otherwise stabilize all disturbed soil on stream banks.
- Remove gravel and reestablish stream channel in Eastern Crossing.
- Remove logging debris damming water flow in Eastern Crossing.
- Remove logging debris from stream at Western Crossing.
- Remove collected debris that has formed a dam at Western Crossing

between the dirt and the water to prevent the movement of soil. Bowater representatives agreed to do this as soon as conditions permit.

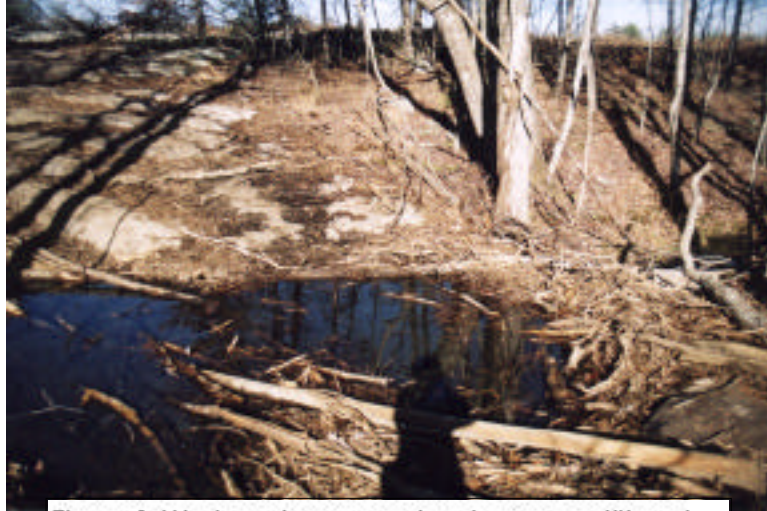
Western Stream Crossing (see Fig. 2)--except where disturbed, the stream bottom is composed of solid rock and small to mid-sized stones. The water was clear both above and below the crossing.

- Haul road leading to the stream was not constructed in compliance with the BMPs (no water bars or broad based dips)
- Roads were not stabilized by seeding vegetation
- Logging debris was deposited and left in the stream causing point source pollution.
- Logging debris had been piled or had collected at the downstream edge of the crossing forming a damn that prevented the movement of aquatic species.

Figure 2. Western stream crossing. Large quantities of logging debris has been left in this stream. Some debris had collected at right of photo forming a dam.

(11) Complaint: Logging debris left in stream
See number four above
