Tennessee ForestWatch Water Quality and Best Management Practices Report

County: Van Buren County, Tennessee

Inspection Date: June 16, 2001

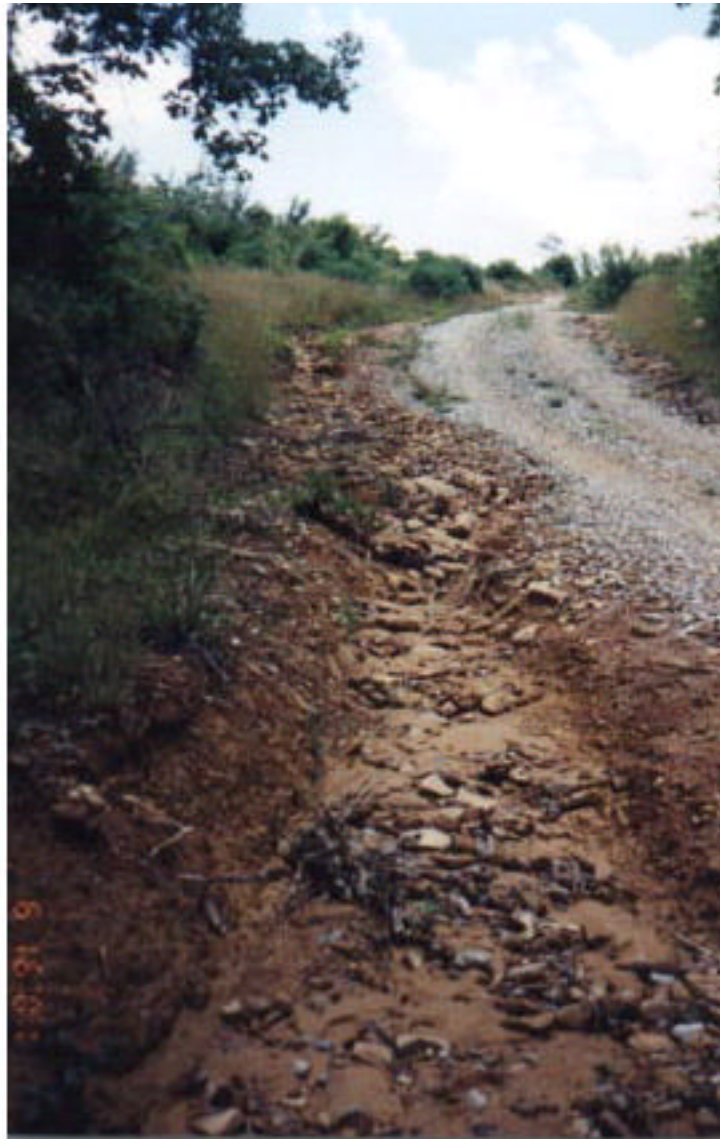
The first violation encountered at this site is the result of erosion channels forming on the road leading to this stream crossing (figure 2). The road approaching the stream was constructed at a grade of approximately 30 percent and an erosion channel has formed. This erosion channel is now 12 inches deep in some areas and is delivering sand and silt directly into the stream.

Figure 2. Erosion Channel beside road above the stream crossing. This channel is delivering silt directly to the stream.

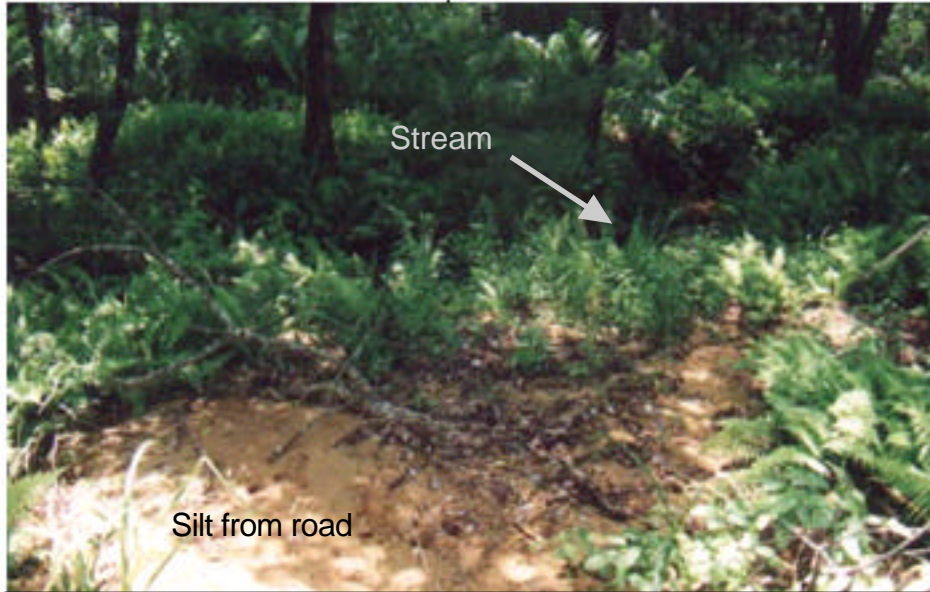
So much silt has traveled down this erosion channel that a small “beach” has formed on the bank of the stream (figure 3). However, during rain events, the silt and sand collected on this “beach” are delivered into the stream. The silt and sand collected on the banks of the stream are another source of point source pollution (EPA definition of point source pollution).

Figure 3. Silt collecting on bank of stream below the road shown in figure 2.

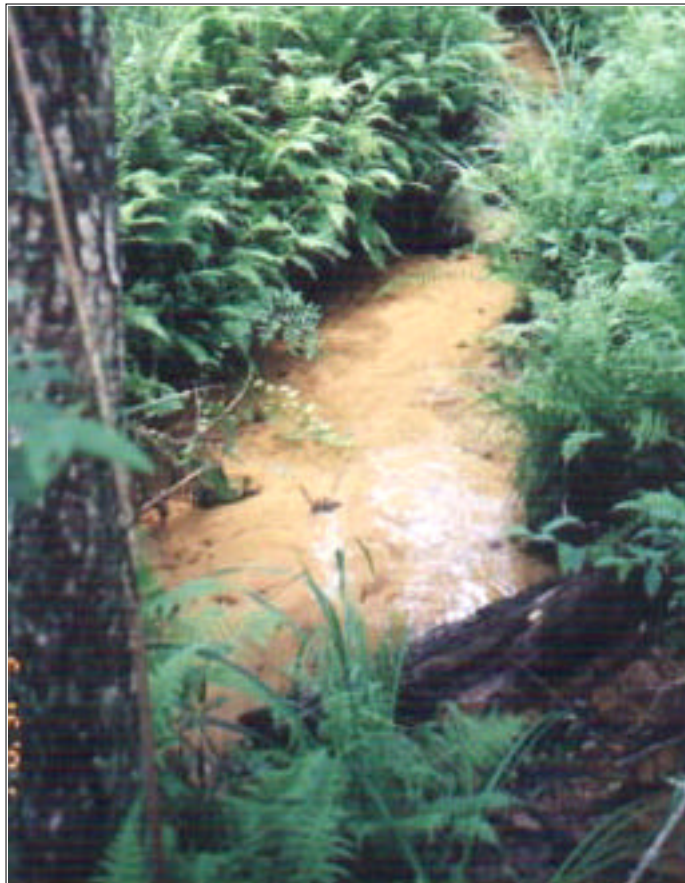
The sources of pollution shown in figures 2 and 3 are delivering large amounts of silt to this unnamed tributary of Rocky River to cause the high turbidity shown in figure 4. As a result of this pollution, almost no light is penetrating the water in this stream and large amounts of sediment are being deposited.

Figure 4. Badly silted stream below road shown in figure 2

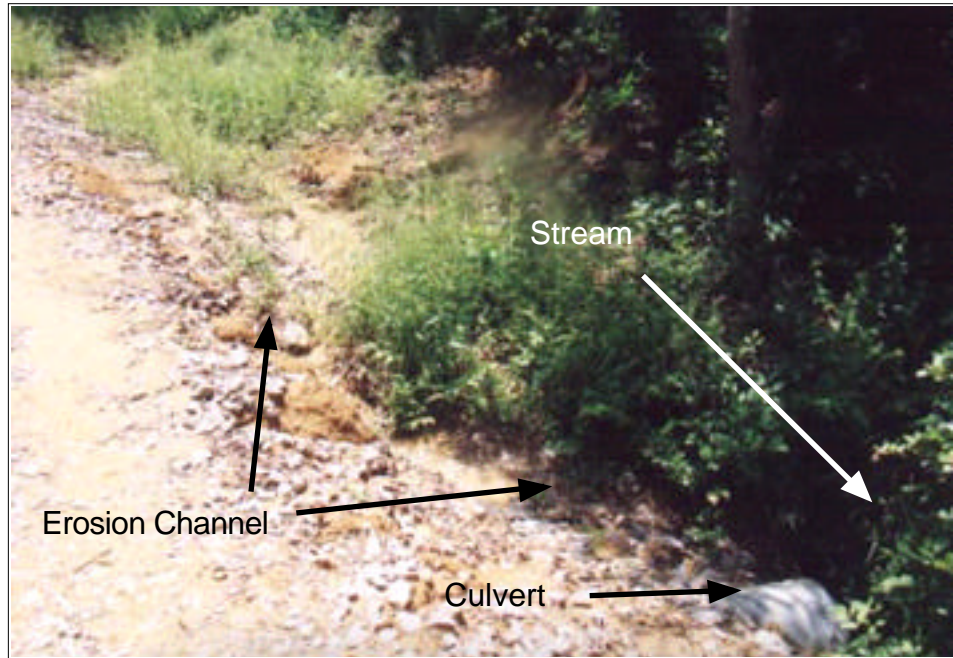
The second violation at this site was encountered at the bottom of the road shown in figure 2. A culvert installed at this location is serving to carry the stream under the road. Stormwater has formed an erosion channel at the edge of this road and silt that washes off the distal portion of the road is entering the stream thru a channel at the side of this culvert. Figure 5 shows the erosion channel that directs the runoff into the stream at the culvert.

Figure 5. Erosion channel and culvert where runoff enters the stream

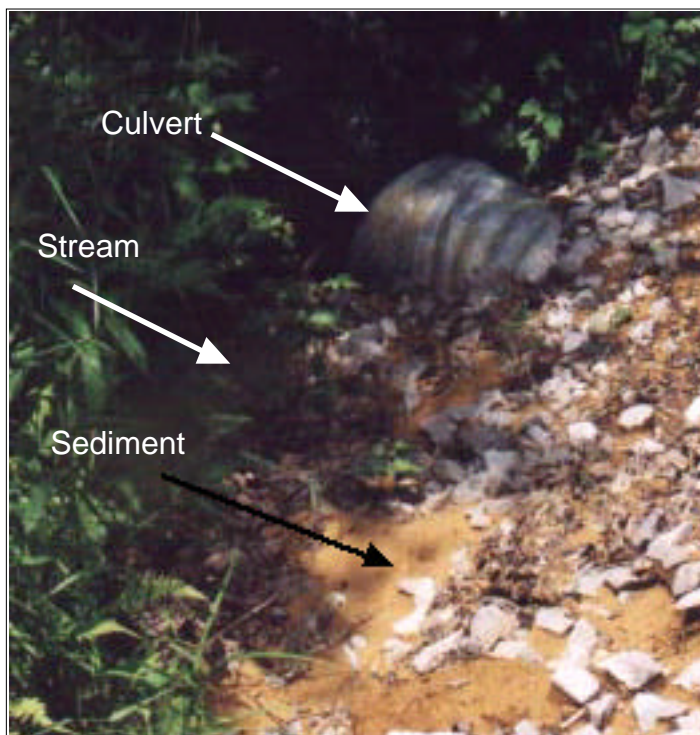
Figure 6 shows the sediment collected at the culvert that will enter the stream with the next rain event. A channel has formed at the side of the culvert that allows sediment to enter the stream. This channel is a point source of pollution into this stream.

Figure 6. Sediment collected at side of culvert. This sediment will enter the stream with the next rain event.
