## Tennessee ForestWatch Water Quality and Best Management Practices Report

**Date of Inspection:** May 8, 2002

**Location:** Walt Reed Rd. Grandview, TN in Rhea County (See Fig. 1). Go to the end of Walt Reed Road. The area in this report is just beyond the end of the road on the left.

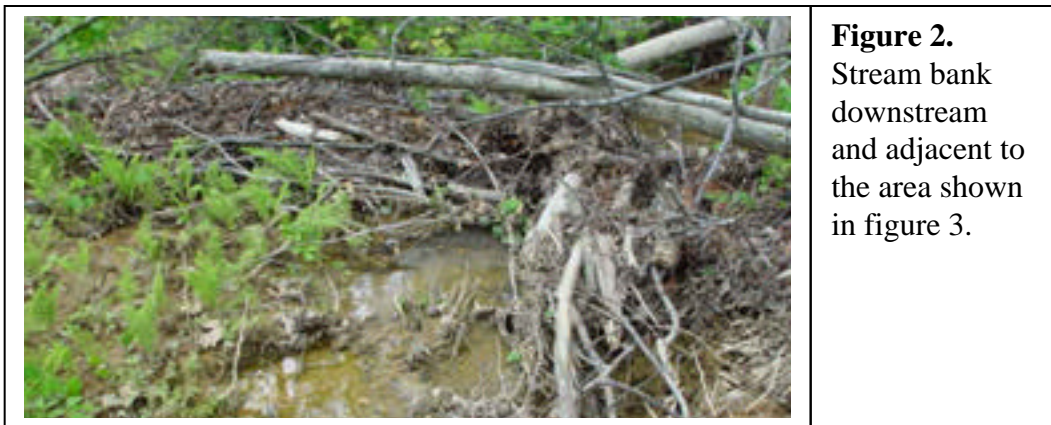
Figure 2 shows the stream bank down stream and immediately adjacent to the cut area. The banks are well stabilized by vegetation—mostly ferns—and the roots of trees growing near the stream. Figure 3 shows the banks of the stream in the logged area just upstream from figure 2. In this logged area, the banks are nearly denuded of vegetation

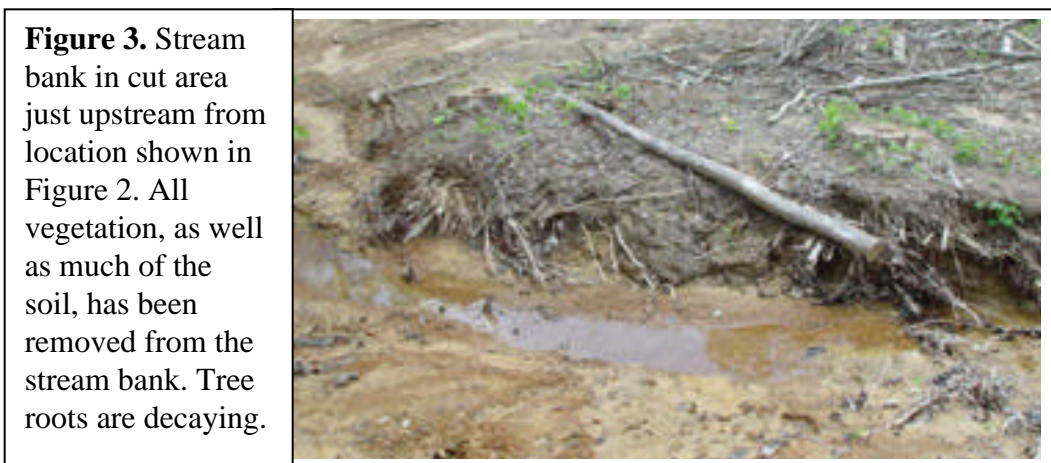
and the banks are eroding into the stream. Tree roots that once stabilized the bank (see SMZ removal) are now decaying allowing the banks to slough off into the stream.

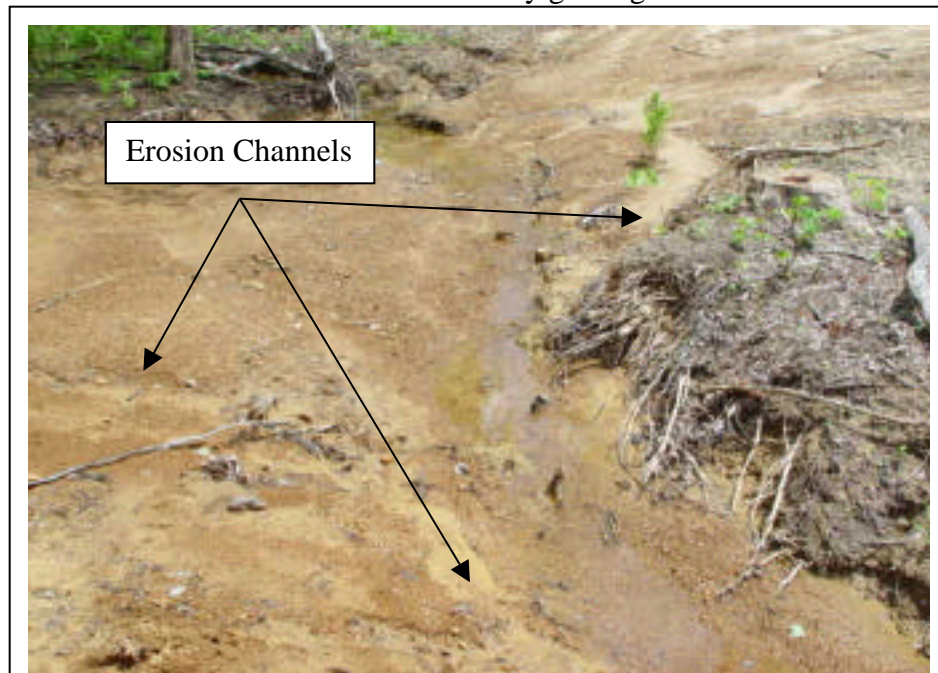
Erosion channels are forming on this site and delivering silt into the stream. Figures 4& 6 show some of these erosion channels. This problem appears to be particularly serious on the unstabilized road that crosses the stream. These small channels are already delivering silt to the stream and this constitutes point source pollution. The soil in this area is very fine and erodible and these erosion channels will only get larger over time.

**Figure 4.** Erosion channels forming and delivering sediment to stream

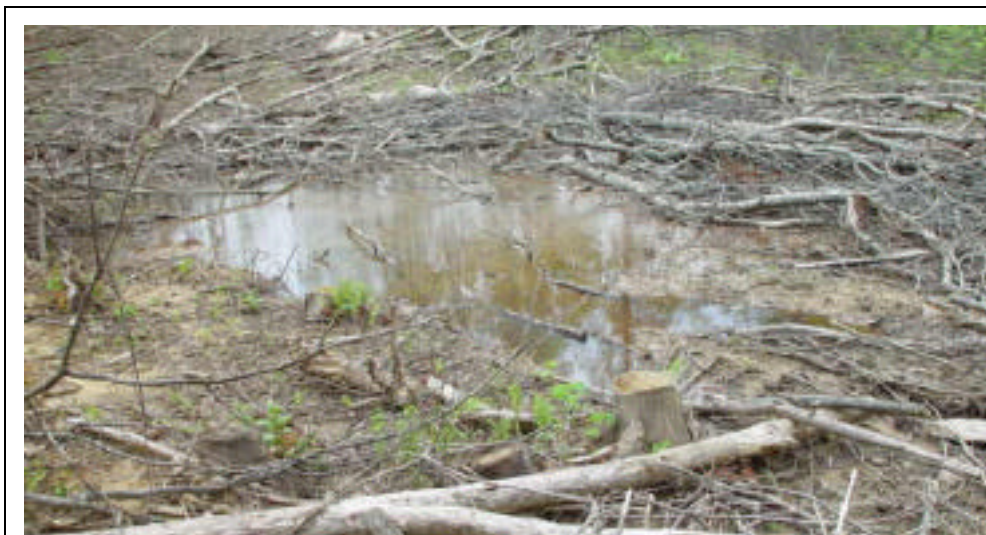
**Figure 5.** Wetland area impacted by heavy equipment and logging debris

A small wetland/marshy area is located adjacent to and to the east of the stream shown in figures 1-4. The predominant remaining vegetation in this wetland is fern. A road has been built across this wetland and according to federal law this road should have been removed prior to the retirement of the site.

Figure 5 shows a portion of the wetland area. No SMZ was retained in this area and woody logging debris was left in the water. This also constitutes point source pollution.. There are also imprints of tracks of heavy equipment in the wetland

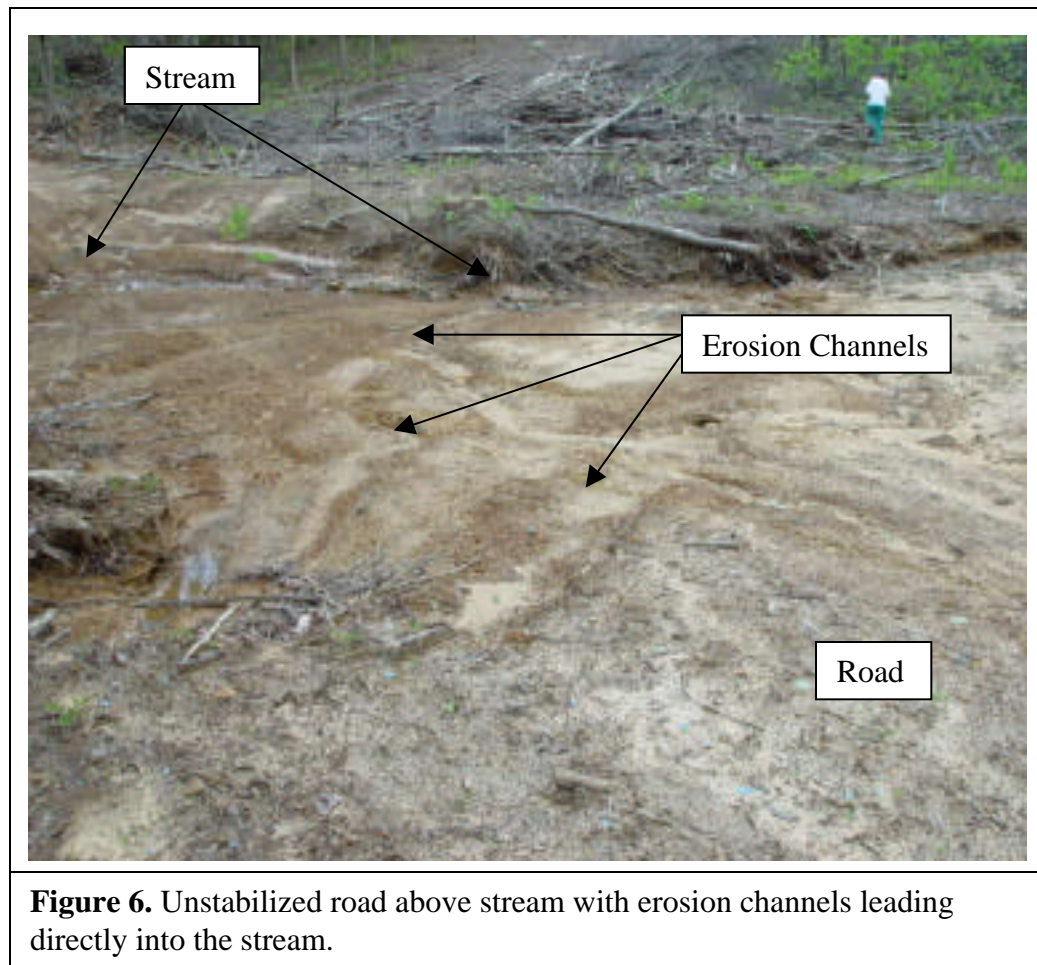
The road that crosses the wetland and stream has not been stabilized. Figure 6 shows that no attempt has been made to reseed, remove, or waterbar this road. The slope of this road

varies from approximately 20% to about 10% just prior to crossing the stream, and erosion channels are forming on the road and delivering silt to the stream (see figures 4 and 6).

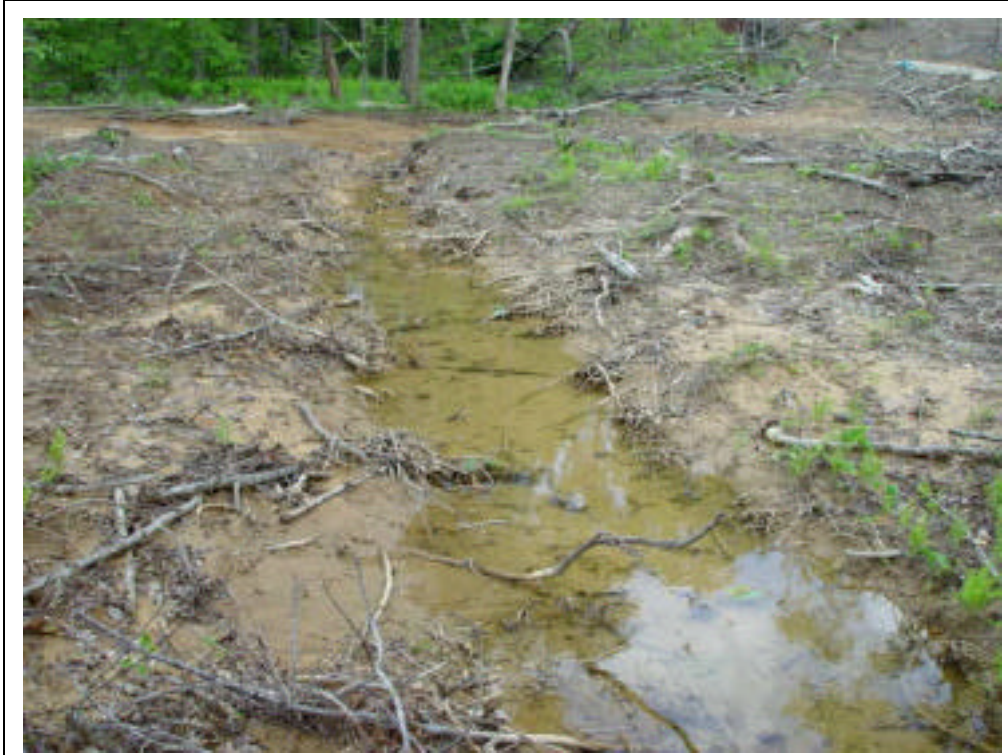
The SMZ has been totally removed on approximately 30-50 yards of stream bank as well as around the wetland shown in figure 5. All trees ranging from saplings to 18 inches in

diameter were removed from the streamside for a distance of about 50 feet where the slope ranges from 10-20%. A SMZ about 10 feet wide remains around the wetland area north of the road but this is inadequate to protect water quality even in a relatively flat area. Figure 7 shows part of the area where the SMZ has been totally removed.

**Figure 7.** A portion of the stream where the SMZ has been totally removed
