## TENNESSEE FORESTWATCH WATER QUALITY AND BEST MANAGEMENT PRACTICES REPORT

**Date of inspection:** February 1, 2001

**Location:** South of Hwy. 52 between Elgin and Rugby, Tennessee. From Elgin travel 2.8 miles on Hwy. 52 (see fig. 1). Turn left on dirt road entering Bowwater property. Travel .9 miles to the long row of oil storage tanks and approximately .3 miles after the tanks, the road forks in 3 directions. Take the road to the right into the woods and go .4 miles to the location of the violation ( we recorded lat. 36 20.008, long. 84 39.436 but are not positive about the accuracy of these coordinates).

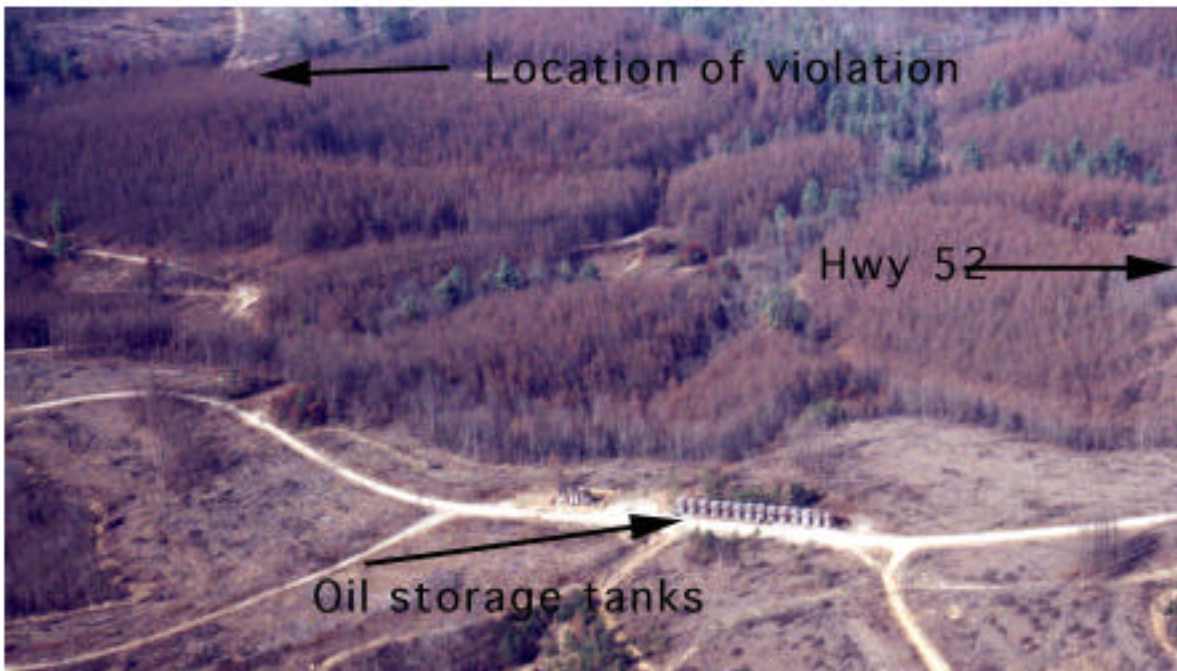
**Figure 2.** Location of the violation relative to Highway 52 and a row of 17 oil storage tanks just south of Highway 52. The impacted stream is just below a clearcut area shown at the upper left of this photograph.

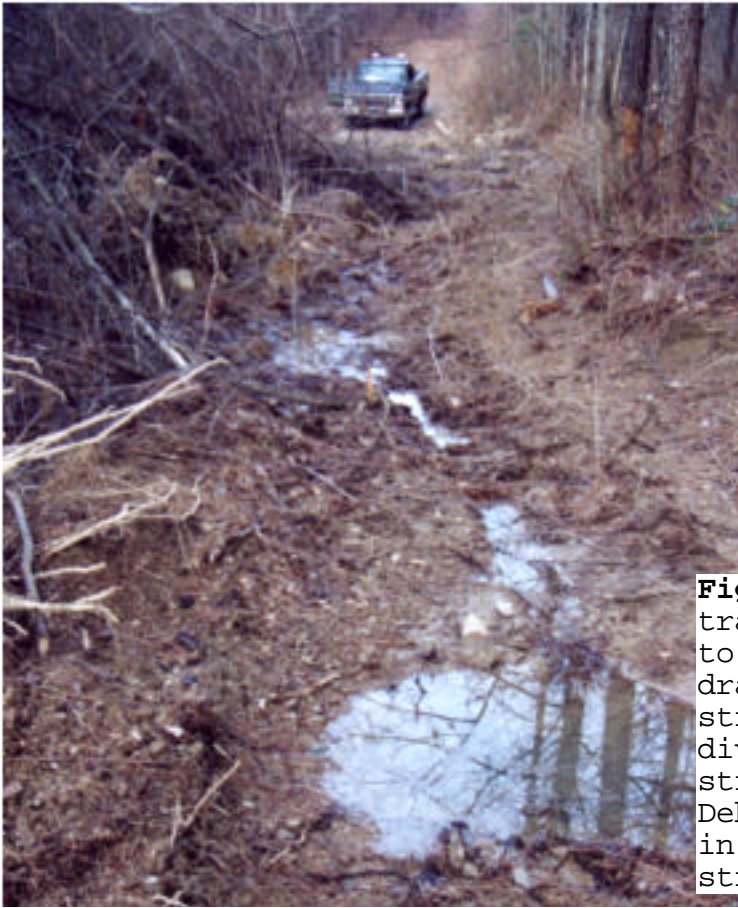
The damage to this stream appears to be the result of the intrusion of a skidder or dozer into the SMZ below several large clearcuts. The equipment appears to have run into and within a few feet of the stream causing damage to the stream banks, diverting the stream, and creating conditions that allow sediment to enter the stream. In addition, the stream channel has been completely obliterated at the road crossing and the water is running diffusely across the road where it crosses the stream.

BMPs recommend that roads and skidder trails be constructed above and away from streams. This skidder trail was constructed below and in the impacted stream causing the stream to enter the skidder trail and wash sediment into the waters of the state. Due to this non-compliance with the state's BMPs, the stream banks have been destroyed, the stream has been diverted from its original channel, and the stream is now flowing down the skidder trail onto the road that crosses the stream. The vegetation and soil displaced by the heavy equipment is now in the stream causing stream diversion and pollution. It is a violation to divert a stream, and it is a violation to cause pollution by placing debris in the stream. Further, we contend that the erosion caused by the diverted water flowing on the skidder trail and reentering the stream constitutes point source pollution and therefore is not exempt from the forestry exemption from pollution of the state's waters.

**Figure 3.** Skidder trail located next to stream and now draining the stream and diverting the stream flow. Debris at left is in the original stream channel.

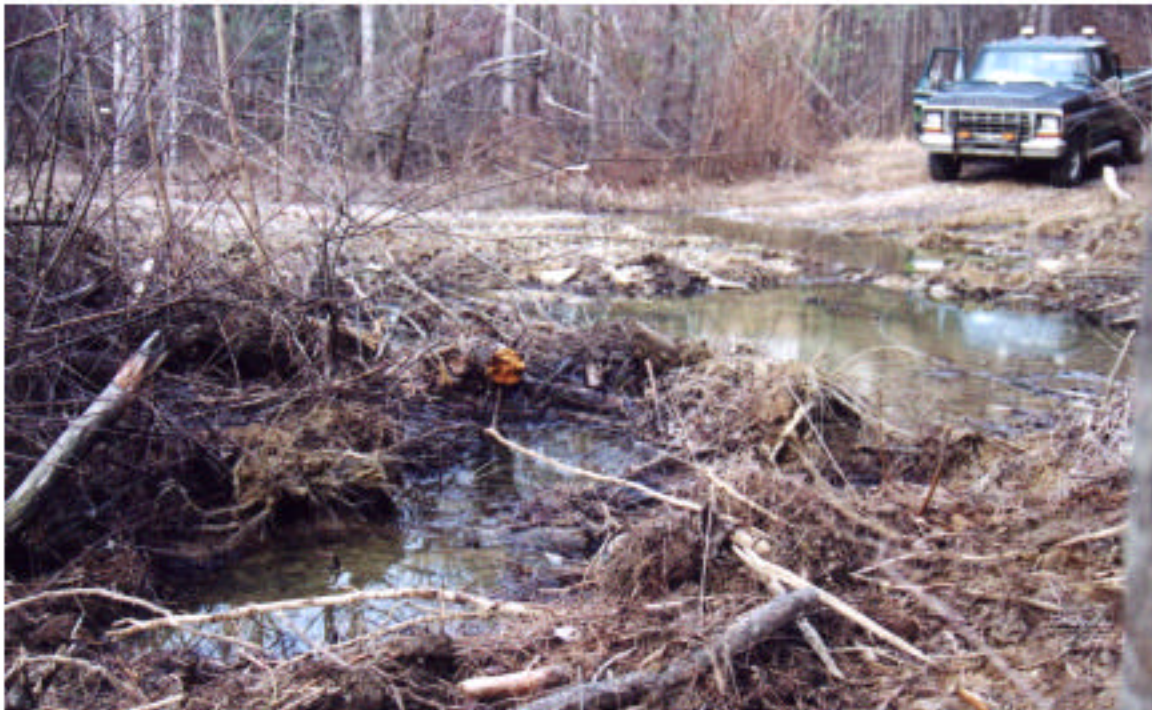
Woody debris and soil has been left in the stream where the stream crosses the logging road (figure 4). This debris and soil has caused pollution of the state's waters. The entire reach of the stream from the skidder trail to the logging road showed obvious evidence of pollution from siltation.

**Figure 4.** Debris in diverted stream where the stream crosses the logging road. This area shows obvious evidence of pollution caused by the placement and construction of the skidder trail shown in figure 3.
